**ARBORICULTURAL SURVEY**  
**at**  
**93 Main Street**  
**Little Downham**  
**Ely**  
**Cambridgeshire**  
**CB6 2SX**

18335c/TT – Rev 1

- 1.1.1 An Arboricultural review has been requested by our client (**Building Validation Solutions**) in relation to ongoing subsidence damage at **93 Main Street, Little Downham, Ely, Cambridgeshire, CB6 2SX**.

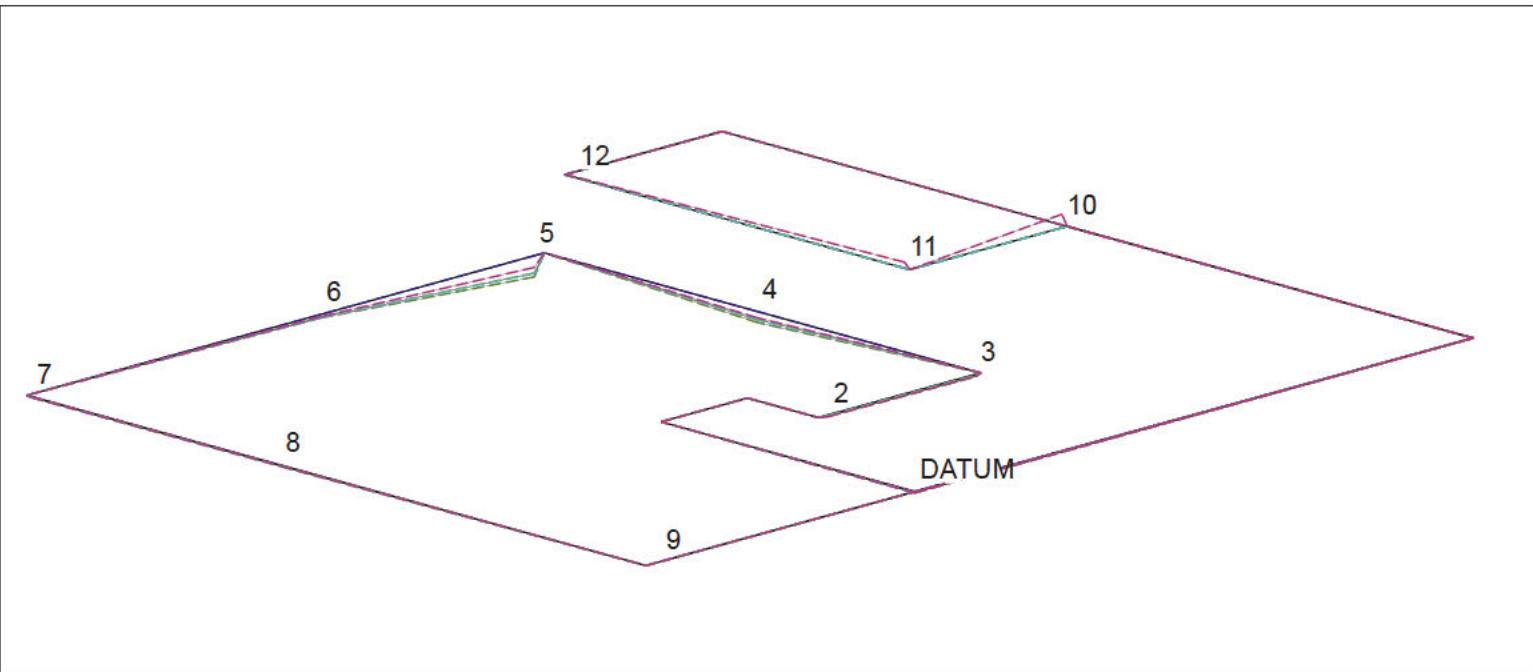
# Relative Movement (Relative Survey, for illustration purposes only)

- 3.5.1 Level readings at the subject property are being monitored in twelve separate locations. The first level readings were measured in June 2022, with further readings taken in August, October and December 2022 and in February 2023.
- 3.5.2 The results indicate seasonal movement, with subsidence in August 2022 when the weather was warmer/drier then showing signs of recovery from October 2022 through to February 2023, when the weather was wetter.
- 3.5.3 All the monitoring results can be viewed in the following tables.

Visits	2	3	4	5	6	7	8	9
07/06/2022	N/A	N/A	N/A	N/A	N/A	N/A	N/A	N/A
17/08/2022	-0.40 ↓	-0.70 ↓	-6.60 ↓	-14.10 ↓	-2.50 ↓	-0.70 ↓	-0.70 ↓	0.00 =
14/10/2022	-0.60 ↓	-1.10 ↓	-2.40 ↓	-3.30 ↓	-0.40 ↓	0.20 ↑	0.20 ↑	0.00 =
23/12/2022	-0.20 ↓	0.10 ↑	2.00 ↑	2.80 ↑	0.40 ↑	-0.30 ↓	-0.70 ↓	0.00 =
23/02/2023	-0.20 ↓	0.10 ↑	1.80 ↑	5.00 ↑	0.70 ↑	0.10 ↑	0.40 ↑	0.00 =

Visits	10	11	12	DATUM
07/06/2022				N/A
17/08/2022				-0.90 ↓
14/10/2022				-0.10 ↓
23/12/2022	0.00 =	0.00 =	0.00 =	0.00 =
23/02/2023	11.10 ↑	4.90 ↑	0.60 ↑	0.00 =

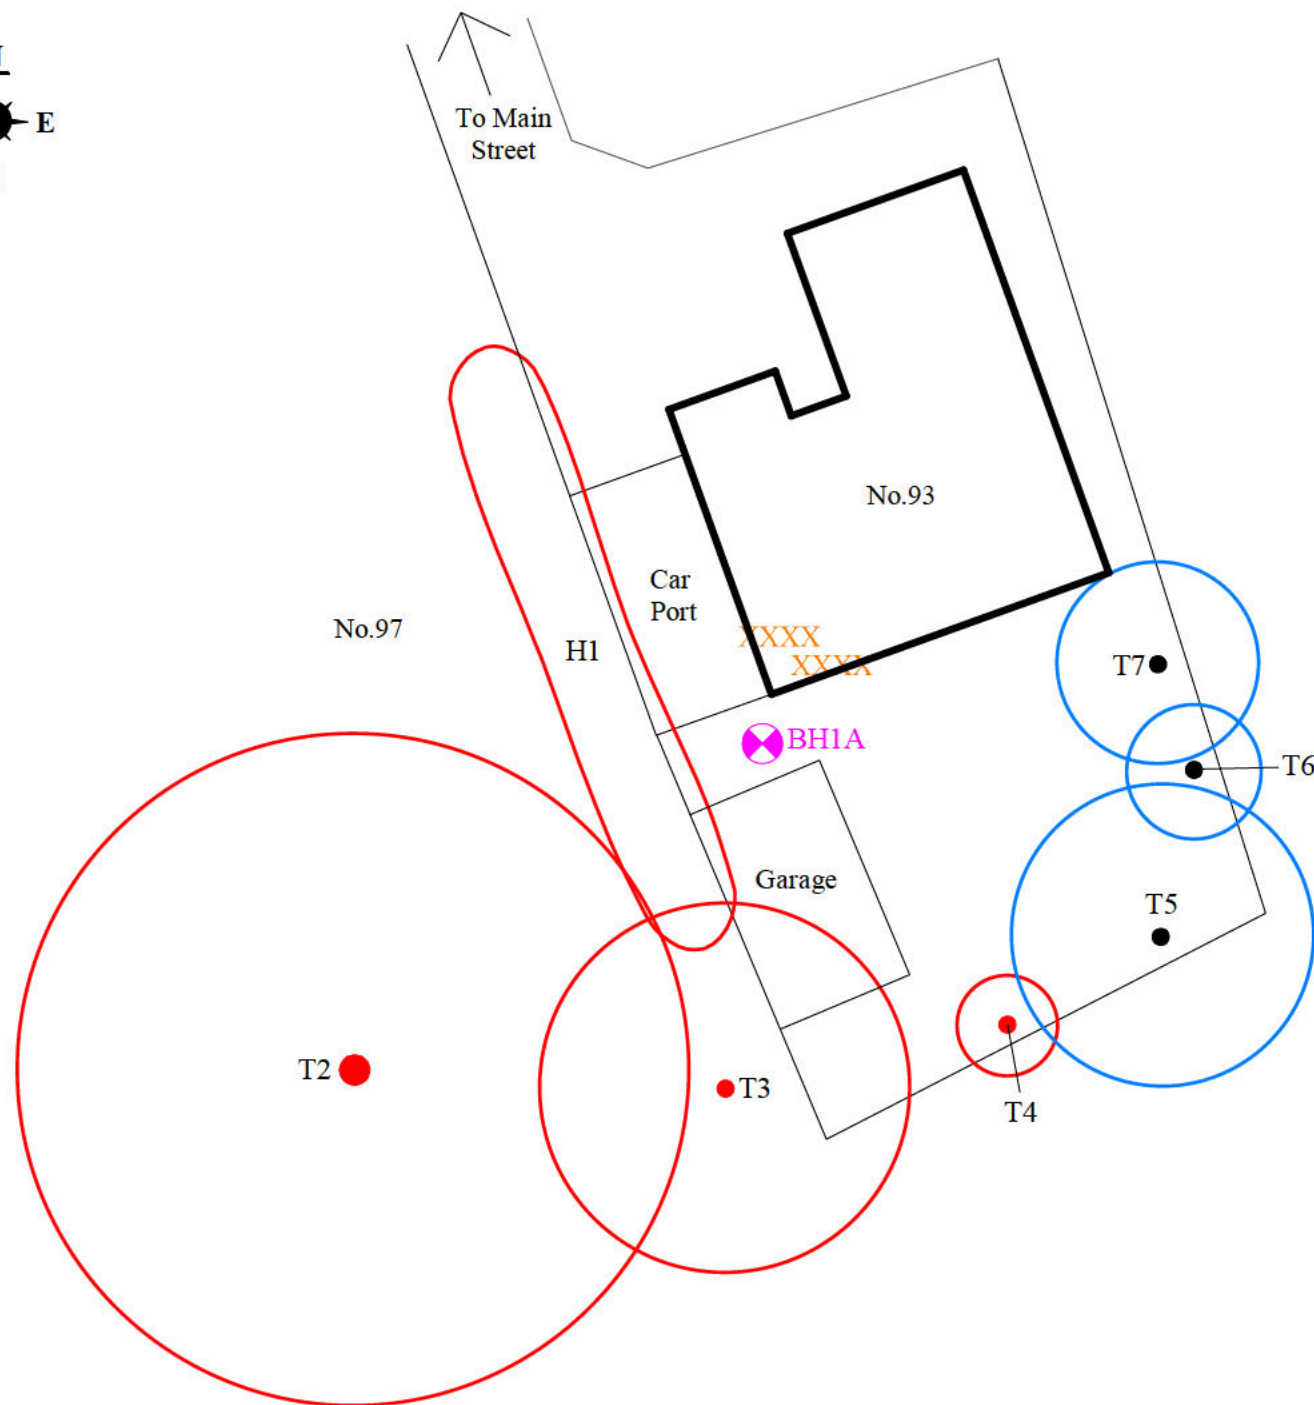
## Appendix 2: Site Plan

- 1.3.1 The subject property is a two-storey, detached house with a detached garage.
- 1.3.2 Damage has occurred to the rear right-hand corner of the building when viewed from the front (as indicated on the Site Plan at **Appendix 2**).
- 1.3.3 Damage has now also been reported to the garage and the boundary wall between No.93 and No.97 Main Street.
- 1.3.4 The distance between the vegetation surveyed and the building is measured from the closest part of the property.

- 6.3 We remain satisfied that the Poplar tree (identified as **T2**) remains the principal cause of the damage to the house, especially considering its size and the roots identified. In addition, **T2** is also potentially contributing to the subsidence damage reported to the garage. To negate its influence on the house and garage, the only vegetation management option available is to remove **T2** and treat its stump to prevent regrowth, as previously advised.

- 6.4 With regards to the damaged boundary wall, based on the species, the location, and the size of the adjacent hedge (**H1**), based on probability, these specimens are the most likely cause of the damage reported. It should also be noted that **H1** could also be potentially contributing to the damage observed to the house and garage.

- 6.5 With regards to the damaged garage, as mentioned above, **T2** is likely to be contributing to this. However, considering the species, the size, and the location of **H1**, **T3** and **T4**, these trees are also likely to be contributing to the damage.

- 6.6 To negate their influence on the boundary wall, the garage and the house, we have recommended the removal of **H1**, **T3** and **T4** (with the stumps of **T3** and **T4** being treated to prevent regrowth).

- 6.7 We consider the vegetation identified as **T5**, **T6** and **T7** to be of possible future concern to the subject property, if left unmanaged. We have therefore recommended that **T5**, **T6** and **T7** be maintained at their current height and spread over the forthcoming years. These works are only recommended as a precaution and are not considered a priority to resolve the damage observed at the subject property.

Item	Species	Recommended Action	Location	Planning Restriction
H1	Leyland Cypress	Remove to ground level.	95 and 97 Main Street	Conservation Area
T2	Poplar	Remove to ground level and treat the stump to prevent regrowth.	97 Main Street	Conservation Area
T3	Lime	Remove to ground level and treat the stump to prevent regrowth.	97 Main Street	Conservation Area
T4	Cherry	Remove to ground level and treat the stump to prevent regrowth.	Subject Property	Conservation Area
T5	Copper Beech	Maintain at current height and spread over the forthcoming years.	Subject Property	Conservation Area
T6	Camperdown Elm	Maintain at current height and spread over the forthcoming years.	Subject Property	Conservation Area
T7	Walnut	Maintain at current height and spread over the forthcoming years.	Subject Property	Conservation Area
